# Access Compliance Report Public Rights-of-Way (Curb Ramps)

Main Street: LOS PATRONES PKWY Cross Street: COW CAMP RD Location: N

ADA ID: RPRK211130113356 Ramp Type: Type 1 - Perpendicular Initial Pass/Fail: Pass Overall Compliance: No Severity Score: 0

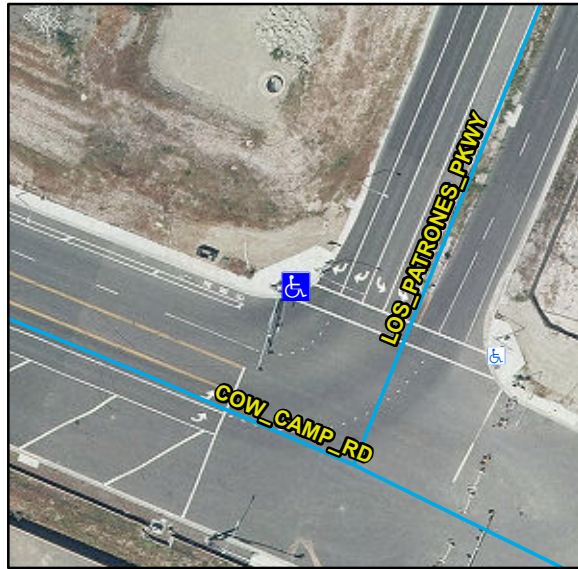
| Compliance | Description | Data | Compliance | Description | Data |
|---|---|---|---|---|---|
| No | Landing Run Slope (%) | 2.5 | N/A | Flare Traversable RT | No |
| No | Ramp Inside Crosswalk 1 | No | Yes | Ramp Inside Crosswalk 2 | N/A |
| Yes | Gutter Ponding | No | No | Curb Slope | 10.4 |

Remove & Replace Entire Ramp. Restripe Crosswalk.
