# Access Compliance Report Public Rights-of-Way (Curb Ramps)

| Main Street: CHIQUITA_CANYON_DR | | Cross Street: LOS_PATRONES_PKWY | | Location: | N |
| ADA ID: RPRK211130120705 | Ramp Type: Type 1 - Perpendicular | Initial Pass/Fail: Fail | Overall Compliance: No | Severity Score: | 15 |

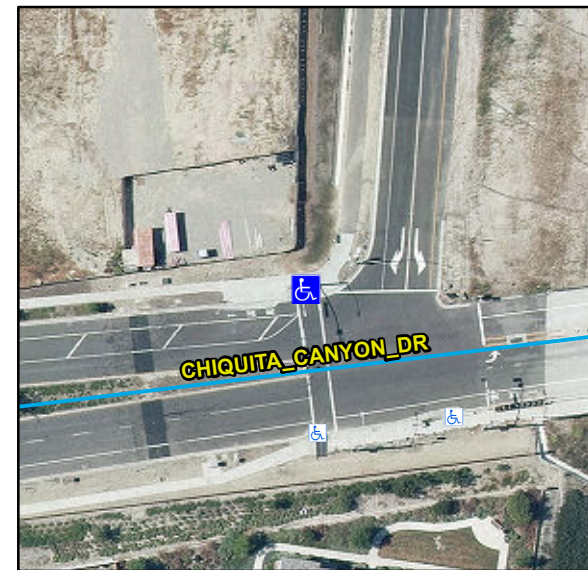
| Compliance | Description | Data | Compliance | Description | Data |
|---|---|---|---|---|---|
| No | Ramp Run Slope (%) | 8.9 | N/A | Flare Slope LT (%) | N/A |
| Yes | Overall Surface Condition: <b>Acceptable</b> | | Yes | Perp Joint Present | Yes |

**Remove & Replace Entire Ramp. Restripe Crosswalk.**

**R304.2.2, STD 1115**
