# Access Compliance Report Public Rights-of-Way (Curb Ramps)

Main Street: SUERTE\_ST Cross Street: N/A Location: N

ADA ID: RPRK211130121552 Ramp Type: Type 4 - Parallel Initial Pass/Fail: Fail Overall Compliance: No Severity Score: 2

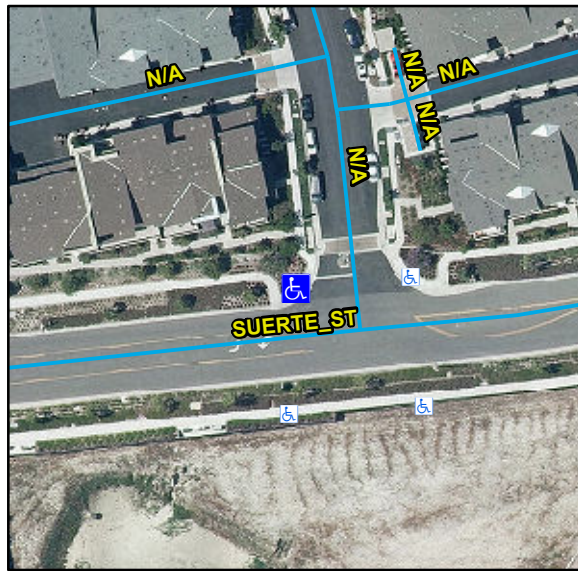
| Compliance | Description | Data | Compliance | Description | Data |
|---|---|---|---|---|---|
| No | Ramp Cross Slope LT (%) | 2.1 | Yes | Ramp Cross Slope RT (%) | 1.1 |

Remove & Replace Curb Ramp With Two New Directional Ramps or Equivalent.

R304.5.3, STD 1115

Total Cost: \$ 4000
