# Access Compliance Report Public Rights-of-Way (Curb Ramps)

Main Street: N/A Cross Street: SUERTE\_ST Location: NE

ADA ID: RPRK211130121829 Ramp Type: Type 4 - Parallel Initial Pass/Fail: Fail Overall Compliance: No Severity Score: 30

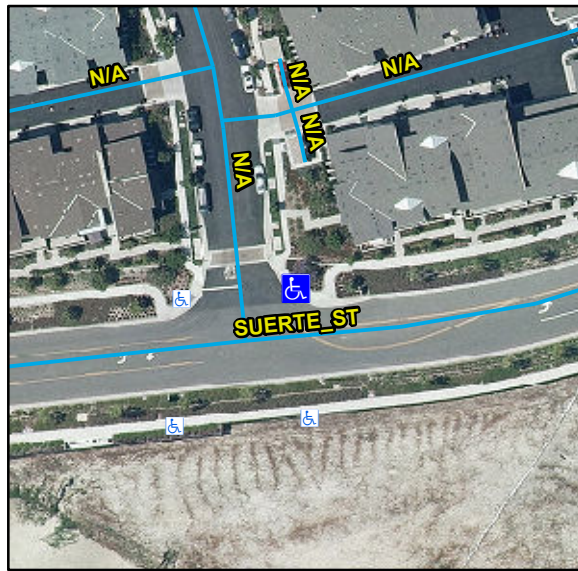
| Compliance | Description | Data | Compliance | Description | Data |
|---|---|---|---|---|---|
| Yes | Ramp Run Slope LT (%) | 6.9 | No | Ramp Run Slope RT (%) | 13.4 |

Remove & Replace Curb Ramp With Two New Directional Ramps or Equivalent.

R304.3.2, STD 1115
