# Access Compliance Report Public Rights-of-Way (Curb Ramps)

Main Street: AIROSO\_ST Cross Street: SUERTE\_ST Location: SW

ADA ID: RPRK211130122150 Ramp Type: Type 4 - Parallel Initial Pass/Fail: Pass Overall Compliance: No Severity Score: 5

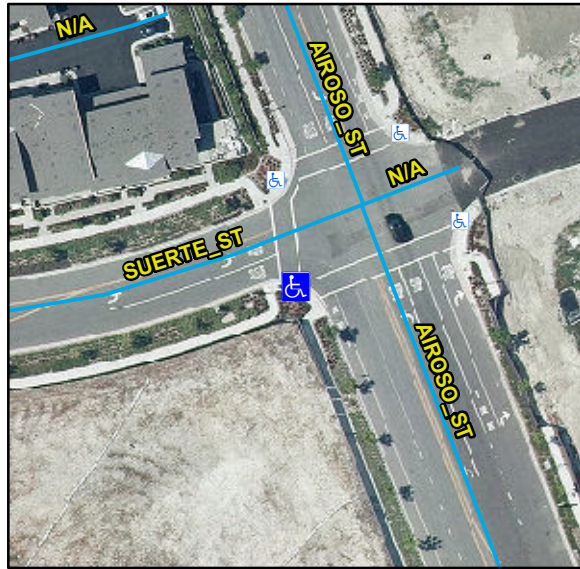
| Compliance | Description | Data | Compliance | Description | Data |
|---|---|---|---|---|---|
| No | Gutter Run Slope (%) | 5.5 | | Road Cross Slope (%) | 5.6 |

Remove & Replace Gutter.

R304.5.4, STD 1115
