# Access Compliance Report Public Rights-of-Way (Curb Ramps)

Main Street: SUERTE\_ST Cross Street: AIROSO\_ST Location: NW

ADA ID: RPRK211130122536 Ramp Type: Type 4 - Parallel Initial Pass/Fail: Fail Overall Compliance: No Severity Score: 2

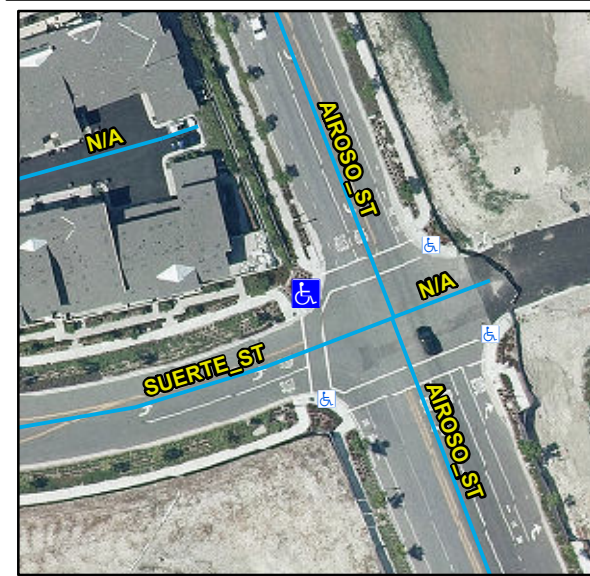
| Compliance | Description | Data | Compliance | Description | Data |
|---|---|---|---|---|---|
| No | Ramp Cross Slope LT (%) | 2.5 | Yes | Ramp Cross Slope RT (%) | 0.8 |
| N/A | Gutter Ponding | N/A | No | Curb Slope | 10.2 |

Possible Solutions:  
**Remove & Replace Curb Ramp With Two New Directional Ramps or Equivalent.**

OC Std/PROW:  
**R304.2.2, R304.5.3, STD 1115**

Total Cost: \$ 4000
