# Access Compliance Report Public Rights-of-Way (Curb Ramps)

Main Street: AIROSO\_ST Cross Street: N/A Location: NE

ADA ID: RPRK211130122822 Ramp Type: Type 4 - Parallel Initial Pass/Fail: Fail Overall Compliance: No Severity Score: 15

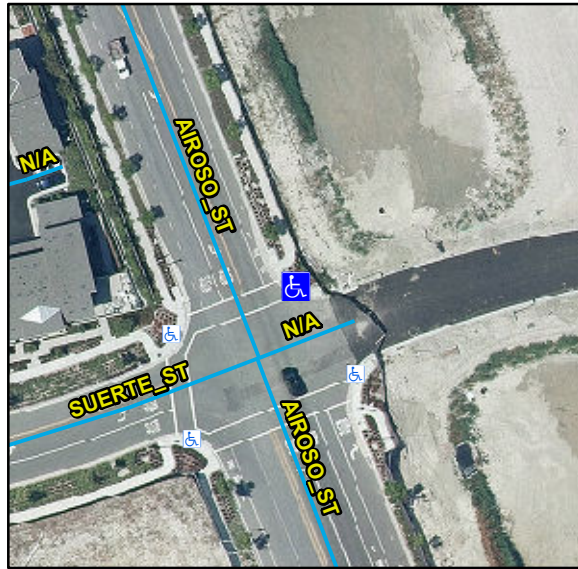
| Compliance | Description | Data | Compliance | Description | Data |
|---|---|---|---|---|---|
| No | Ramp Run Slope LT (%) | 8.7 | Yes | Ramp Run Slope RT (%) | 1.1 |

**Remove & Replace Curb Ramp With Two New Directional Ramps or Equivalent. Restripe Crosswalk.**

**R304.3.2, STD 1115**
