# Access Compliance Report Public Rights-of-Way (Curb Ramps)

Main Street: CHIQUITA\_CANYON\_DR Cross Street: AIROSO\_ST Location: SE

ADA ID: RPRK211130124100 Ramp Type: Type 1 - Perpendicular Diagonal Initial Pass/Fail: Pass Overall Compliance: No Severity Score: 0

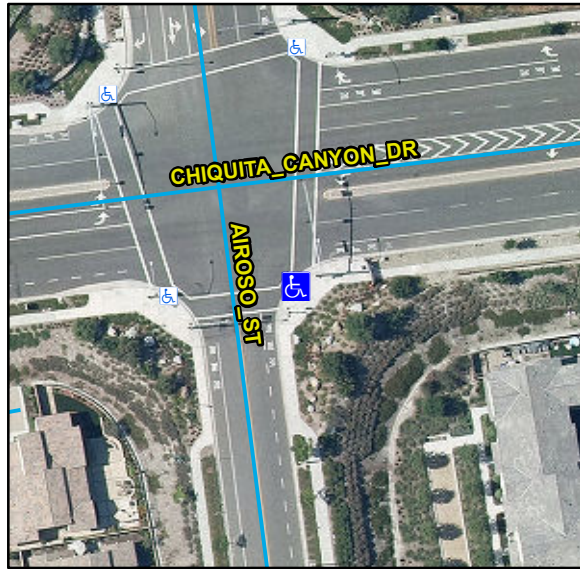
| Compliance | Description | Data | Compliance | Description | Data |
|---|---|---|---|---|---|
| Yes | Gutter Ponding | No | No | Curb Slope | 9.6 |
| No | Gutter Cross Slope (%) | 2.2 | | | |

Remove & Replace Curb Slope. Remove & Replace Gutter.

R304.2.2, R304.5.3, STD 1115
