# Access Compliance Report Public Rights-of-Way (Curb Ramps)

Main Street: AIROSO\_ST Cross Street: CHIQUITA\_CANYON\_DR Location: SW

ADA ID: RPRK211130124807 Ramp Type: Type 1 - Perpendicular Diagonal Initial Pass/Fail: Pass Overall Compliance: No Severity Score: 2

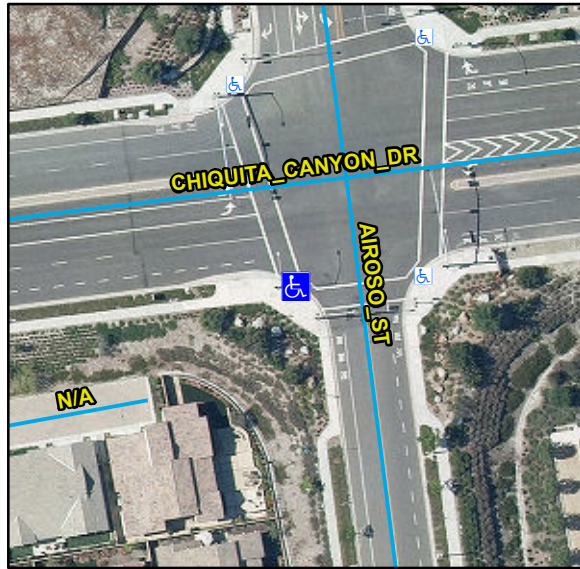
| Compliance | Description | Data | Compliance | Description | Data |
|---|---|---|---|---|---|
| No | Ramp Cross Slope (%) | 2.9 | N/A | Flare Traversable LT | No |
| No | Landing Run Slope (%) | 2.9 | N/A | Flare Traversable RT | No |
| Yes | Gutter Ponding | No | No | Curb Slope | 12.4 |
| No | Gutter Cross Slope (%) | 3.5 | | | |

Remove & Replace Curb Ramp With Two New Directional Ramps or Equivalent. Remove & Replace Gutter.

R304.2.2, R304.5.3, R304.2.2-Perp, R304.3.2-Para, STD 1115
