# Access Compliance Report Public Rights-of-Way (Curb Ramps)

Main Street: CHIQUITA\_CANYON\_DR Cross Street: AIROSO\_ST Location: NW

ADA ID: RPRK211130125354 Ramp Type: Type 1 - Perpendicular Diagonal Initial Pass/Fail: Pass Overall Compliance: No Severity Score: 0

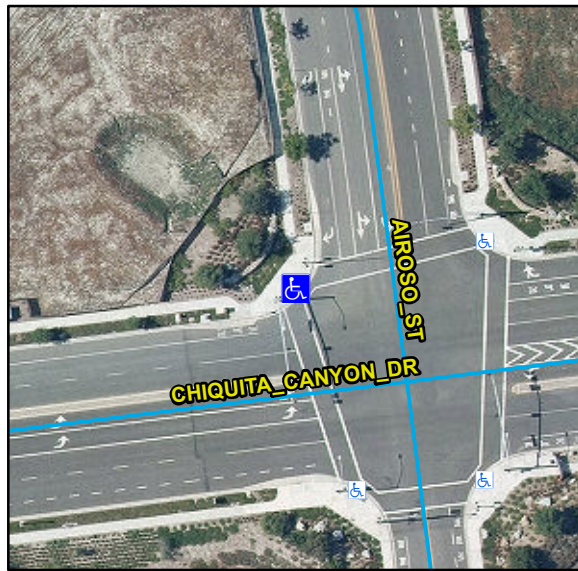
| Compliance | Description | Data | Compliance | Description | Data |
|---|---|---|---|---|---|
| N/A | Landing Movement Obstructed? | Yes | Yes | DWS Contrast | Yes |
| | Landing Movement Type | Bushes | Yes | DWS Length (in) | 36 |
| Yes | Gutter Ponding | No | No | Curb Slope | 8.8 |
| No | Gutter Cross Slope (%) | 2.5 | | | |

Remove & Replace Curb Ramp With Two New Directional Ramps or Equivalent. Remove & Replace Gutter.

R304.2.2, R304.2.1, R304.5.3, STD 1115
