# Access Compliance Report Public Rights-of-Way (Curb Ramps)

Main Street: MEDANO\_ST Cross Street: TOPAZ\_ST Location: SW

ADA ID: RPRK211130130919 Ramp Type: Type 1 - Perpendicular Diagonal Initial Pass/Fail: Pass Overall Compliance: No Severity Score: 6

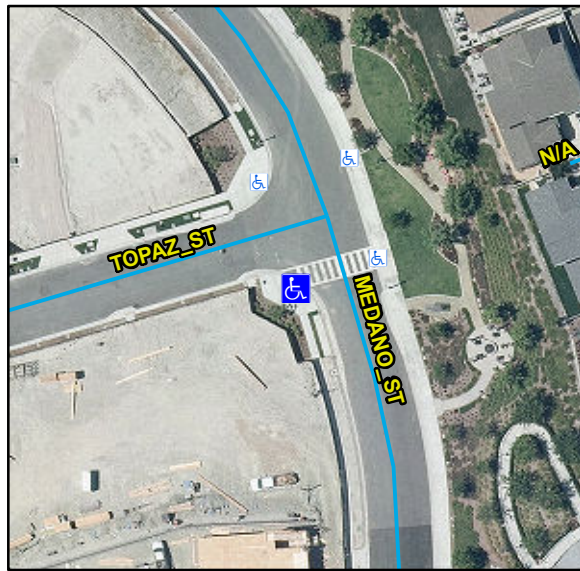
| Compliance | Description | Data | Compliance | Description | Data |
|---|---|---|---|---|---|
| No | Landing Run Slope (%) | 3.4 | N/A | Flare Traversable RT | Yes |
| No | Gutter Run Slope (%) | 7.7 | | Road Cross Slope (%) | 3.8 |
| No | Gutter Cross Slope (%) | 3.4 | | | |

Remove & Replace Landing. Remove & Replace Gutter.
