# Access Compliance Report Public Rights-of-Way (Curb Ramps)

Main Street: TOPAZ\_ST Cross Street: MEDANO\_ST Location: NW

ADA ID: RPRK211130131209 Ramp Type: Type 1 - Perpendicular Diagonal Initial Pass/Fail: Fail Overall Compliance: No Severity Score: 16

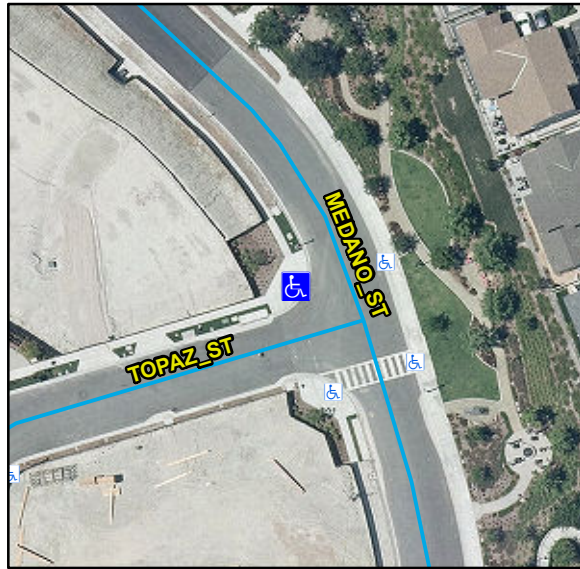
| Compliance | Description | Data | Compliance | Description | Data |
|---|---|---|---|---|---|
| No | Ramp Run Slope (%) | 8.6 | N/A | Flare Slope LT (%) | N/A |
| No | Ramp Cross Slope (%) | 2.7 | N/A | Flare Traversable LT | N/A |

**Remove & Replace Curb Ramp With Two New Directional Ramps or Equivalent.**

**R304.2.2, R304.5.3, STD 1115**
