# Access Compliance Report Public Rights-of-Way (Curb Ramps)

| Main Street: MEDANO_ST | | Cross Street: TOPAZ_ST | | Location: | SW |
| ADA ID: RPRK211130131350 | Ramp Type: Type 4 - Parallel | Initial Pass/Fail: Fail | Overall Compliance: No | Severity Score: | 15 |

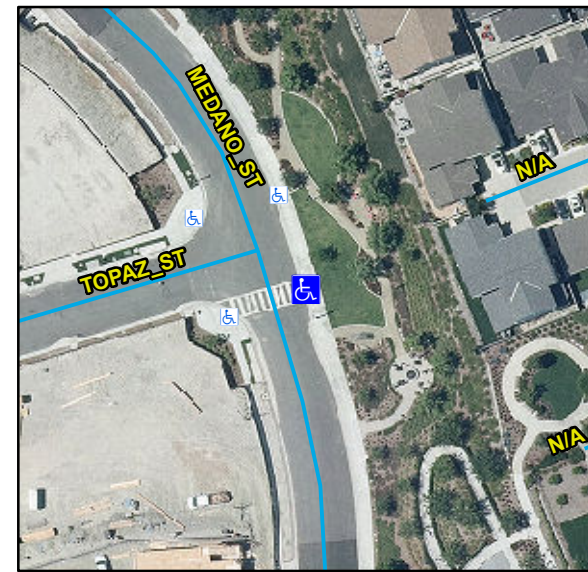
| Compliance | Description | Data | Compliance | Description | Data |
|---|---|---|---|---|---|
| Yes | Ramp Run Slope LT (%) | 2.8 | No | Ramp Run Slope RT (%) | 11.6 |

Remove & Replace Entire Ramp.

R304.3.2, STD 1115
