# Access Compliance Report Public Rights-of-Way (Curb Ramps)

| Main Street: ESENCIA_DR | | Cross Street: MEDANO_ST | | Location: | W |
| ADA ID: RPRK211130131959 | Ramp Type:Type 1 - Perpendicular | Initial Pass/Fail: Pass | Overall Compliance: No | Severity Score: | 0 |

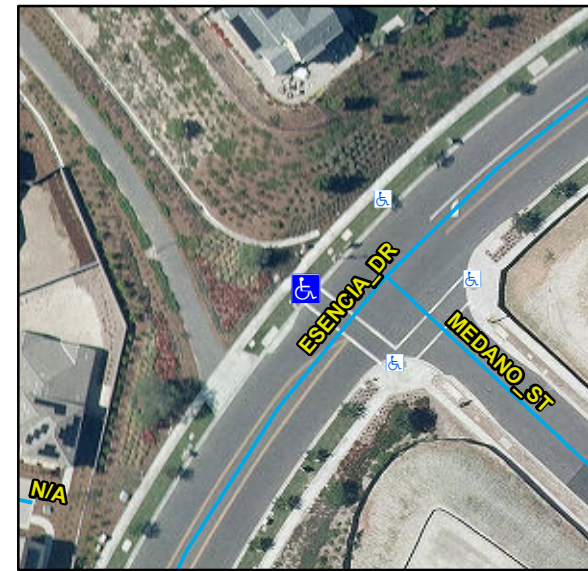
| Compliance | Description | Data | Compliance | Description | Data |
|---|---|---|---|---|---|
| No | Landing Cross Slope (%) | 2.3 | Yes | DWS Provided | Yes |
| No | Ramp Inside Crosswalk 1 | No | Yes | Ramp Inside Crosswalk 2 | N/A |
| No | Gutter Cross Slope (%) | 5 | | | |

Possible Solutions:

**Remove & Replace Entire Ramp. Restripe Crosswalk. Remove & Replace Gutter. Utility Present.**

**R304.2.2, R304.5.3, R207.1, STD 1115**

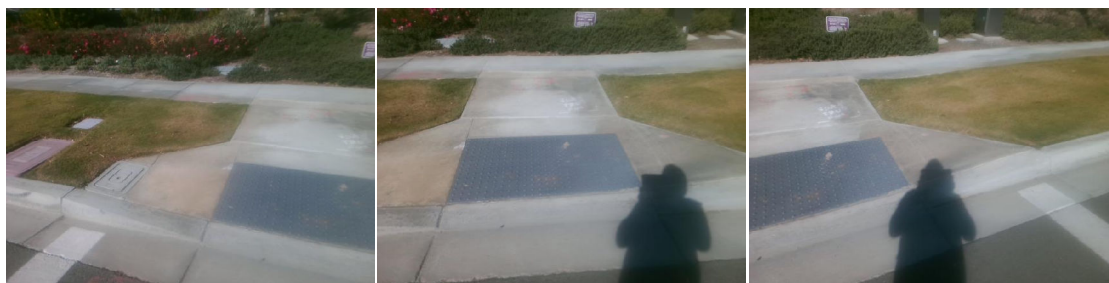
| Compliance | Description | Data | Compliance | Description | Data |
|---|---|---|---|---|---|
| Yes | Obstructions Present? | No | N/A | Utilities Present? | Yes |
