# Access Compliance Report Public Rights-of-Way (Curb Ramps)

| Main Street: AIROSO_ST | | Cross Street: N/A | | Location: | NW |
| ADA ID: RPRK211130133121 | Ramp Type:Type 1 - Perpendicular | Initial Pass/Fail: Fail | Overall Compliance: No | Severity Score: | 30 |

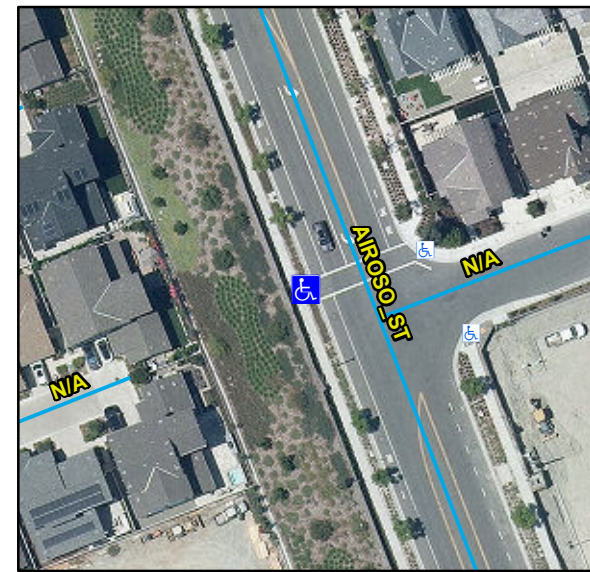
| Compliance | Description | Data | Compliance | Description | Data |
|---|---|---|---|---|---|
| No | Ramp Run Slope (%) | 12.4 | N/A | Flare Slope LT (%) | N/A |

**Remove & Replace Entire Ramp. Restripe Crosswalk.**

**R304.2.2, STD 1115**
