# Access Compliance Report Public Rights-of-Way (Curb Ramps)

Main Street: AIROSO\_ST Cross Street: N/A Location: NE

ADA ID: RPRK211130133216 Ramp Type: Type 4 - Parallel Initial Pass/Fail: Pass Overall Compliance: No Severity Score: 0

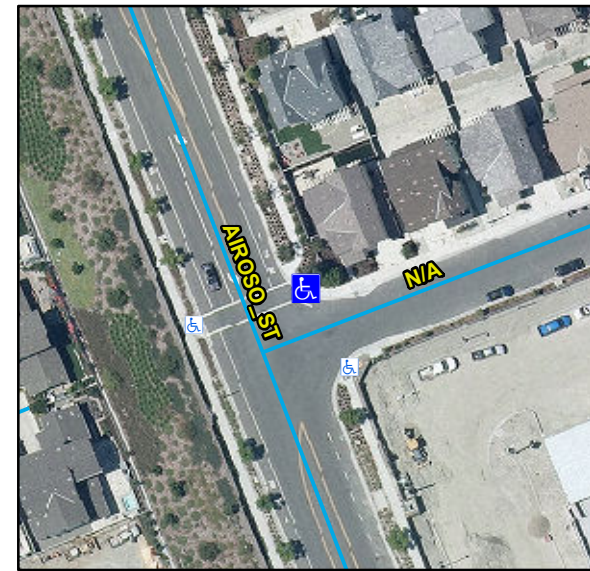
| Compliance | Description | Data | Compliance | Description | Data |
|---|---|---|---|---|---|
| Yes | Gutter Ponding | No | No | Curb Slope | 10.1 |

Possible Solutions:

Remove & Replace Curb Slope.

R304.2.2, STD 1115

Total Cost: \$ 252
