# Access Compliance Report Public Rights-of-Way (Curb Ramps)

Main Street: CROWN\_VALLEY\_PKWY Cross Street: N/A Location: S

ADA ID: RPRK211201112945 Ramp Type: Type 1 - Perpendicular Diagonal Initial Pass/Fail: Fail Overall Compliance: No Severity Score: 32

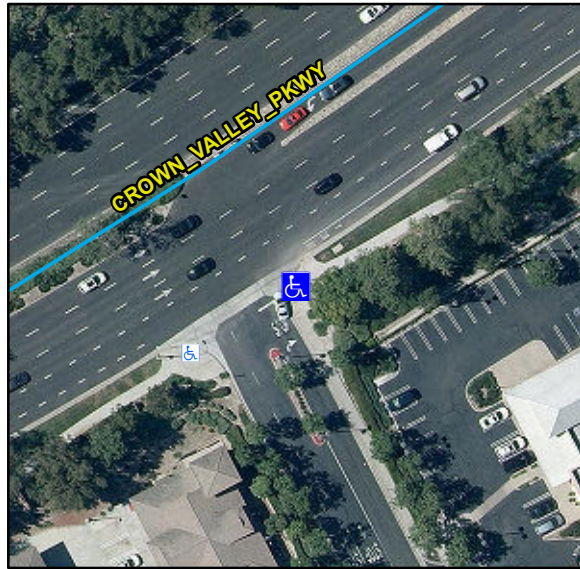
| Compliance | Description | Data | Compliance | Description | Data |
|---|---|---|---|---|---|
| No | Ramp Run Slope (%) | 16.7 | N/A | Flare Slope LT (%) | N/A |
| No | Ramp Cross Slope (%) | 2.6 | N/A | Flare Traversable LT | N/A |

Remove & Replace Curb Ramp With Two New Directional Ramps or Equivalent.

R304.2.2, R204.3, R304.5.3, STD 1115
