# Access Compliance Report Public Rights-of-Way (Curb Ramps)

Main Street: N/A Cross Street: CROWN\_VALLEY\_PKWY Location: S

ADA ID: RPRK211201113125 Ramp Type: Type 1 - Perpendicular Diagonal Initial Pass/Fail: Fail Overall Compliance: No Severity Score: 2

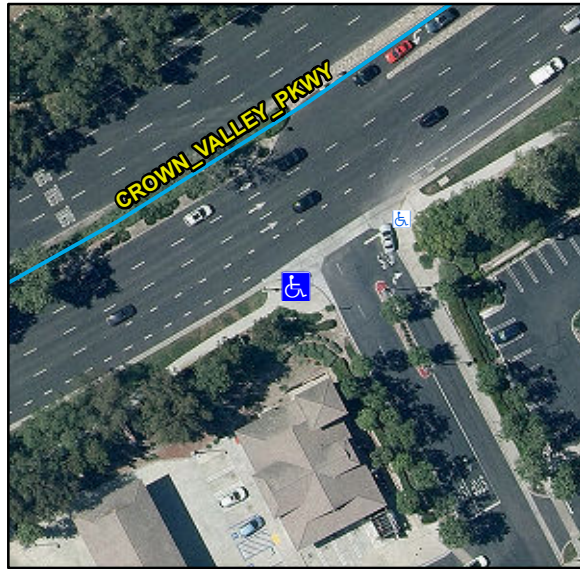
| Compliance | Description | Data | Compliance | Description | Data |
|---|---|---|---|---|---|
| No | Ramp Cross Slope (%) | 4.3 | N/A | Flare Traversable LT | N/A |

Remove & Replace Curb Ramp With Two New Directional Ramps or Equivalent.
