# Access Compliance Report Public Rights-of-Way (Curb Ramps)

Main Street: CROWN\_VALLEY\_PKWY Cross Street: N/A Location: S

ADA ID: RPRK211201113408 Ramp Type: Type 1 - Perpendicular Diagonal Initial Pass/Fail: Fail Overall Compliance: No Severity Score: 16

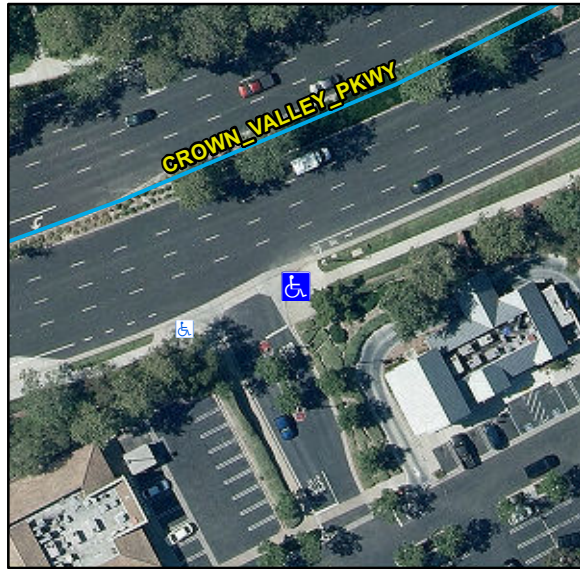
| Compliance | Description | Data | Compliance | Description | Data |
|---|---|---|---|---|---|
| No | Ramp Run Slope (%) | 8.4 | N/A | Flare Slope LT (%) | N/A |
| No | Ramp Cross Slope (%) | 3.8 | N/A | Flare Traversable LT | N/A |

Remove & Replace Curb Ramp With Two New Directional Ramps or Equivalent.

R304.2.2, R204.3, R304.5.3, STD 1115
