# Access Compliance Report Public Rights-of-Way (Curb Ramps)

Main Street: N/A Cross Street: CROWN\_VALLEY\_PKWY Location: S

ADA ID: RPRK211201113712 Ramp Type: Type 1 - Perpendicular Diagonal Initial Pass/Fail: Fail Overall Compliance: No Severity Score: 60

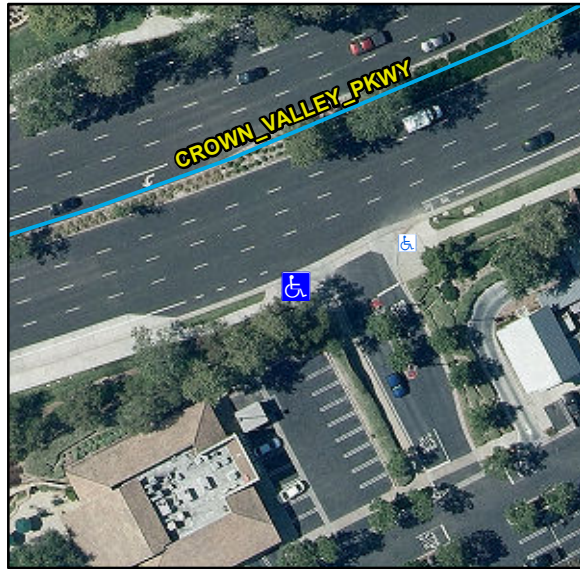
| Compliance | Description | Data | Compliance | Description | Data |
|---|---|---|---|---|---|
| No | Ramp Run Slope (%) | 13.9 | N/A | Flare Slope LT (%) | N/A |
| No | Ramp Cross Slope (%) | 8.5 | N/A | Flare Traversable LT | N/A |

Remove & Replace Curb Ramp With Two New Directional Ramps or Equivalent.

R304.2.2, R204.3, R304.5.3, STD 1115
