# Access Compliance Report Public Rights-of-Way (Curb Ramps)

| Main Street: MOCHA_LN | | Cross Street: LODEN_PASS | | Location: | W |
| ADA ID: RPRK211201114821 | Ramp Type: Type 4 - Parallel | Initial Pass/Fail: Fail | Overall Compliance: No | Severity Score: | 2 |

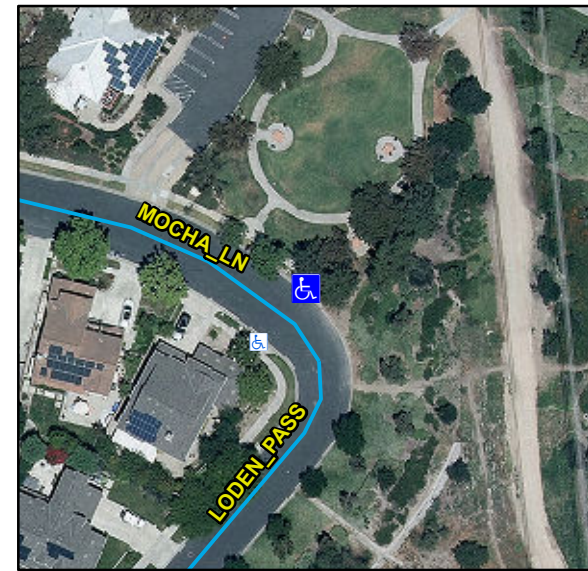
| Compliance | Description | Data | Compliance | Description | Data |
|---|---|---|---|---|---|
| No | Ramp Cross Slope LT (%) | 3.2 | N/A | Ramp Cross Slope RT (%) | -9999 |
| N/A | Gutter Ponding | N/A | Yes | Curb Slope | 4.1 |
| N/A | Gutter Cross Slope (%) | N/A | No | Perpendicular Joint Present | No |

**Remove & Replace Entire Ramp.**

**R204.3, R304.5.3, STD 1115**

Total Cost: \$ 2000
