# Access Compliance Report Public Rights-of-Way (Curb Ramps)

Main Street: AVENIDA\_LA\_PATA Cross Street: VISTA\_MONTANA Location: SW

ADA ID: RPRK211201120737 Ramp Type: Type 1 - Perpendicular Diagonal Initial Pass/Fail: Fail Overall Compliance: No Severity Score: 30

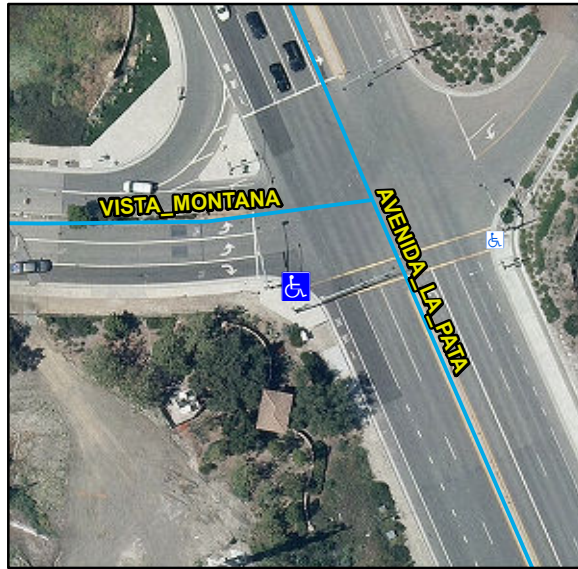
| Compliance | Description | Data | Compliance | Description | Data |
|---|---|---|---|---|---|
| No | Ramp Cross Slope (%) | 7.1 | N/A | Flare Traversable LT | N/A |

Remove & Replace Curb Ramp With Two New Directional Ramps or Equivalent.

R304.2.2, R304.5.3, STD 1115
