# Access Compliance Report Public Rights-of-Way (Curb Ramps)

Main Street: AVENIDA LA PATA Cross Street: VISTA MONTANA Location: SE

ADA ID: RPRK211201121158 Ramp Type: Type 4 - Parallel Initial Pass/Fail: Fail Overall Compliance: No Severity Score: 15

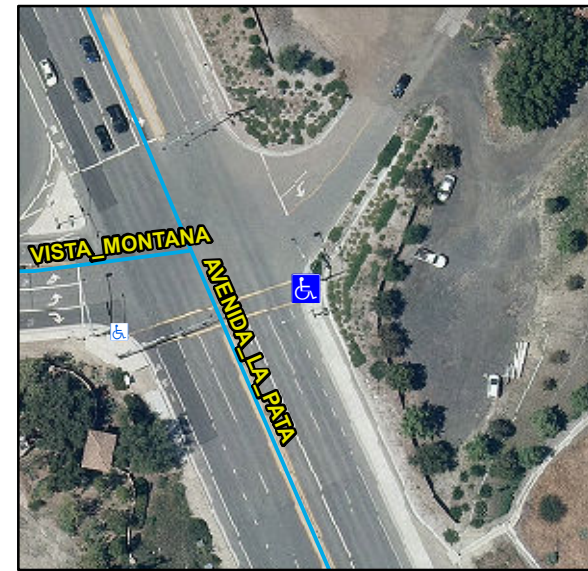
| Compliance | Description | Data | Compliance | Description | Data |
|---|---|---|---|---|---|
| N/A | Ramp Run Slope LT (%) | -9999 | No | Ramp Run Slope RT (%) | 9.5 |

Remove & Replace Entire Ramp.

R304.3.2, STD 1115
