# Access Compliance Report Public Rights-of-Way (Curb Ramps)

Main Street: AVENIDA LA PATA Cross Street: N/A Location: E

ADA ID: RPRK211201122536 Ramp Type: Type 1 - Perpendicular Diagonal Initial Pass/Fail: Fail Overall Compliance: No Severity Score: 2

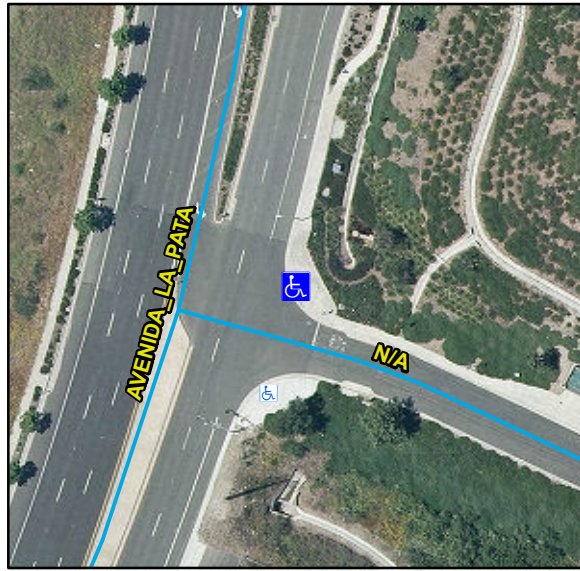
| Compliance | Description | Data | Compliance | Description | Data |
|---|---|---|---|---|---|
| No | Ramp Cross Slope (%) | 4.3 | N/A | Flare Traversable LT | N/A |

**Remove & Replace Curb Ramp With Two New Directional Ramps or Equivalent.**

**R304.2.2, R304.5.3, STD 1115**
