# Access Compliance Report Public Rights-of-Way (Curb Ramps)

Main Street: N/A Cross Street: AVENIDA LA PATA Location: S

ADA ID: RPRK211201122730 Ramp Type: Type 1 - Perpendicular Diagonal Initial Pass/Fail: Fail Overall Compliance: No Severity Score: 2

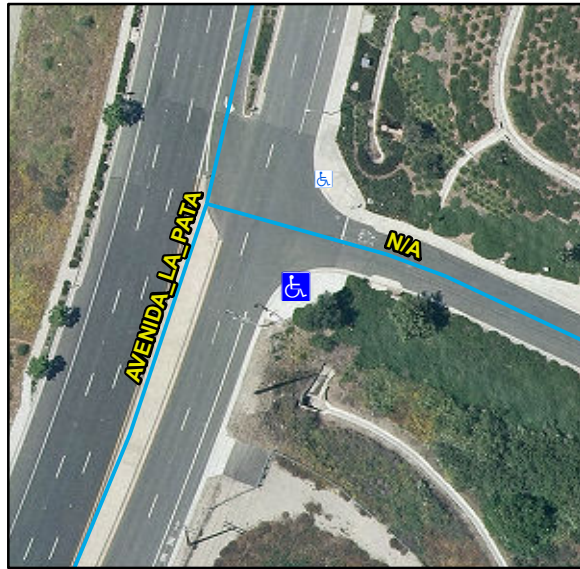
| Compliance | Description | Data | Compliance | Description | Data |
|---|---|---|---|---|---|
| No | Ramp Cross Slope (%) | 2.6 | N/A | Flare Traversable LT | N/A |

**Remove & Replace Curb Ramp With Two New Directional Ramps or Equivalent.**

**R304.5.3, STD 1115**
