# Access Compliance Report Public Rights-of-Way (Curb Ramps)

Main Street: AIROSO\_ST Cross Street: N/A Location: N

ADA ID: RPRK211201130859 Ramp Type: Type 4 - Parallel Initial Pass/Fail: Fail Overall Compliance: No Severity Score: 2

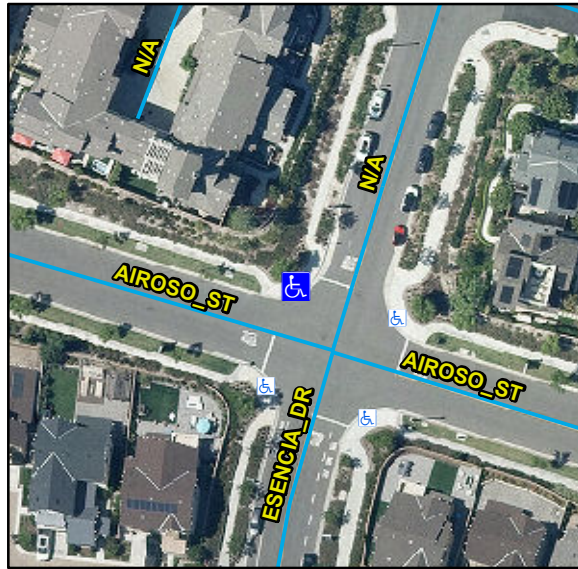
| Compliance | Description | Data | Compliance | Description | Data |
|---|---|---|---|---|---|
| No | Ramp Cross Slope LT (%) | 3.1 | Yes | Ramp Cross Slope RT (%) | 1.3 |
| N/A | Gutter Ponding | N/A | No | Curb Slope | 9.6 |

**Remove & Replace Curb Ramp With Two New Directional Ramps or Equivalent.**

**R304.2.2, R304.5.3, STD 1115**

Total Cost: \$ 4000
