# Access Compliance Report Public Rights-of-Way (Curb Ramps)

Main Street: AMBITO\_ST Cross Street: AIROSO\_ST Location: SW

ADA ID: RPRK211201132508 Ramp Type: Type 3 - Combination 1 Initial Pass/Fail: Fail Overall Compliance: No Severity Score: 32

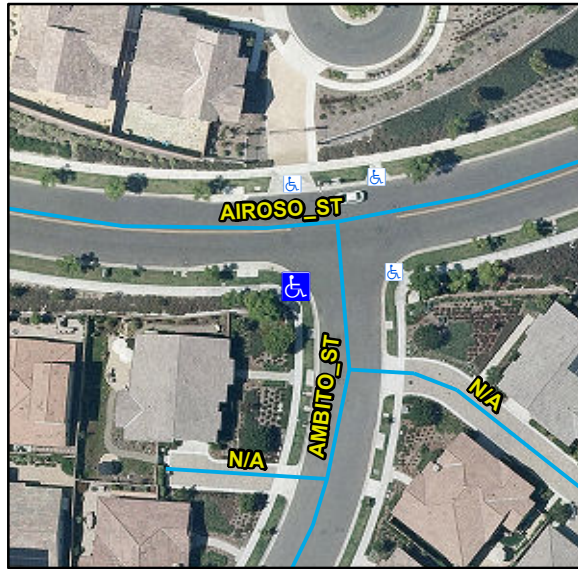
| Compliance | Description | Data | Compliance | Description | Data |
|---|---|---|---|---|---|
| Yes | Ramp Run Slope LT (%) | 2.9 | No | Ramp Run Slope RT (%) | 12.4 |
| No | Ramp Cross Slope (%) | 3.8 | N/A | Flare Traversable LT | N/A |

Remove & Replace Curb Ramp With Two New Directional Ramps or Equivalent.

R304.5.3, R304.3.2, STD 1115
