# Access Compliance Report Public Rights-of-Way (Curb Ramps)

Main Street: AIROSO\_ST Cross Street: AMBITO\_ST Location: SE

ADA ID: RPRK211201133034 Ramp Type: Type 3 - Combination 1 Initial Pass/Fail: Fail Overall Compliance: No Severity Score: 32

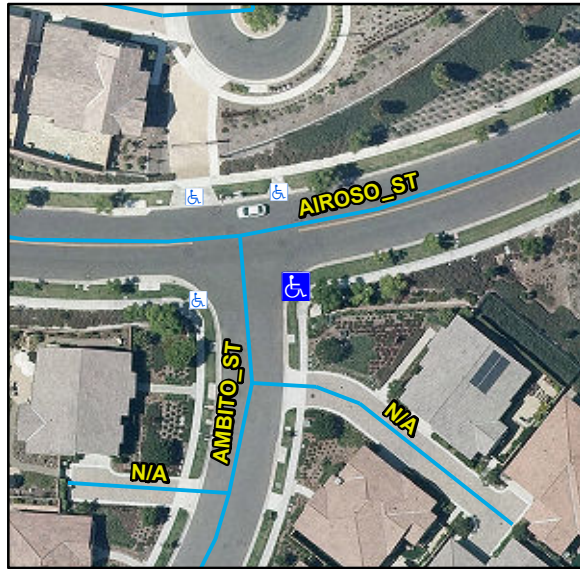
| Compliance | Description | Data | Compliance | Description | Data |
|---|---|---|---|---|---|
| No | Ramp Run Slope LT (%) | 10.2 | No | Ramp Run Slope RT (%) | 12.2 |
| No | Ramp Cross Slope LT (%) | 2.3 | Yes | Ramp Cross Slope RT (%) | 1.3 |
| No | Ramp Cross Slope (%) | 2.8 | N/A | Flare Traversable LT | N/A |

Remove & Replace Curb Ramp With Two New Directional Ramps or Equivalent.

R304.5.3, R304.3.2, STD 1115
