# Access Compliance Report Public Rights-of-Way (Curb Ramps)

Main Street: AIROSO\_ST Cross Street: AMBITO\_ST Location: N

ADA ID: RPRK211201133331 Ramp Type: Type 1 - Perpendicular Initial Pass/Fail: Pass Overall Compliance: No Severity Score: 25

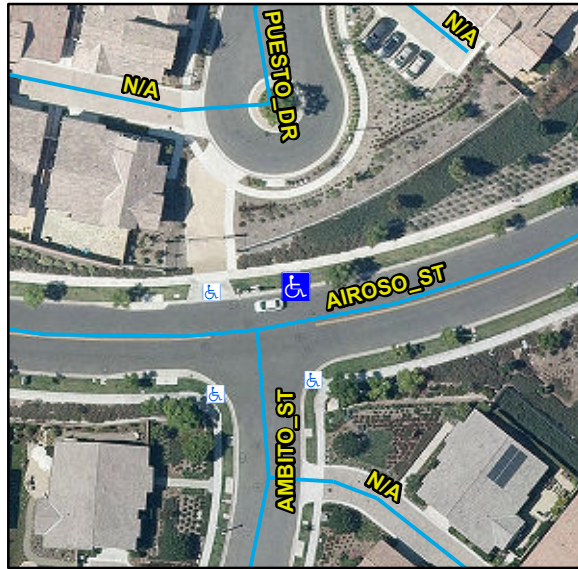
| Compliance | Description | Data | Compliance | Description | Data |
|---|---|---|---|---|---|
| No | Ramp Cross Slope (%) | 6.3 | N/A | Flare Traversable LT | No |
| No | Landing Cross Slope (%) | 6.5 | Yes | DWS Provided | Yes |
| No | Gutter Run Slope (%) | 5.2 | | Road Cross Slope (%) | N/A |
| No | Gutter Cross Slope (%) | 8.6 | | | |

Remove & Replace Entire Ramp. Remove & Replace Gutter.

R304.2.2, R304.5.3, R304.5.4, STD 1115
