# Access Compliance Report Public Rights-of-Way (Curb Ramps)

Main Street: N/A Cross Street: AIROSO\_ST Location: N

ADA ID: RPRK211201133709 Ramp Type: Type 4 - Parallel Initial Pass/Fail: Pass Overall Compliance: No Severity Score: 0

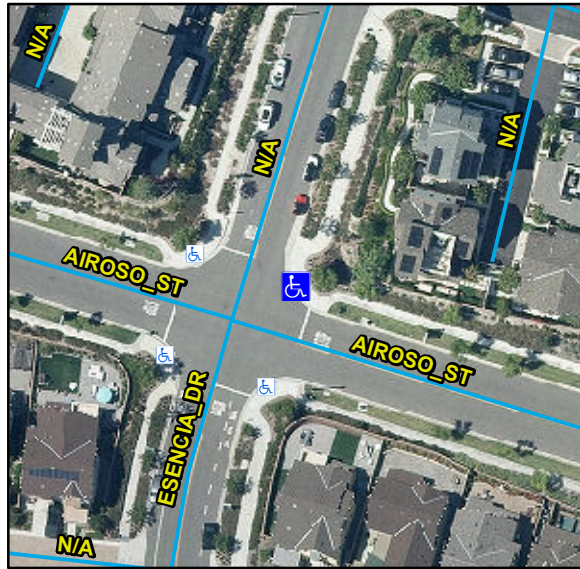
| Compliance | Description | Data | Compliance | Description | Data |
|---|---|---|---|---|---|
| Yes | Gutter Ponding | No | No | Curb Slope | 12 |

Remove & Replace Curb Slope.

R304.2.2, STD 1115

\$ 252
