# Access Compliance Report Public Rights-of-Way (Curb Ramps)

Main Street: N/A Cross Street: ESENCIA\_DR Location: NW

ADA ID: RPRK211201134657 Ramp Type: Type 1 - Perpendicular Diagonal Initial Pass/Fail: Fail Overall Compliance: No Severity Score: 2

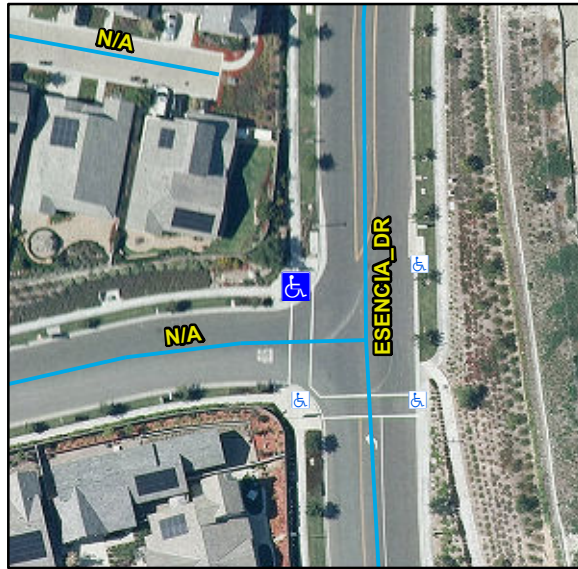
| Compliance | Description | Data | Compliance | Description | Data |
|---|---|---|---|---|---|
| No | Ramp Cross Slope (%) | 3.8 | N/A | Flare Traversable LT | N/A |

Remove & Replace Curb Ramp With Two New Directional Ramps or Equivalent.

R304.2.2, R304.5.3, STD 1115
