# Access Compliance Report Public Rights-of-Way (Curb Ramps)

Main Street: ESENCIA\_DR Cross Street: N/A Location: SE

ADA ID: RPRK211201134939 Ramp Type: Type 4 - Parallel Initial Pass/Fail: Pass Overall Compliance: No Severity Score: 0

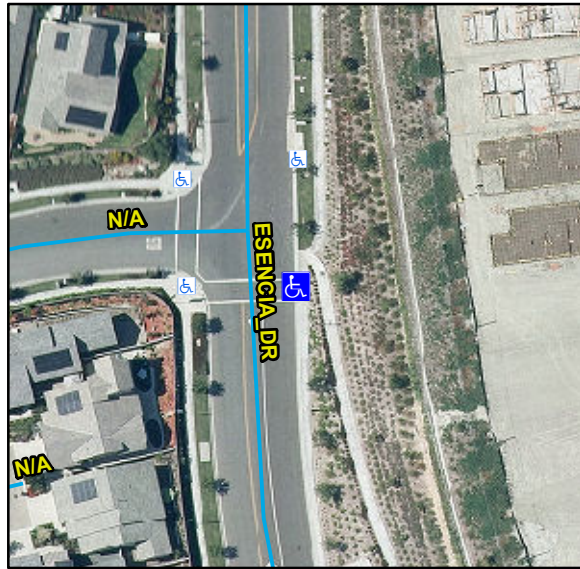
| Compliance | Description | Data | Compliance | Description | Data |
|---|---|---|---|---|---|
| No | Landing Cross Slope (%) | 4.3 | | DWS Offset Type | Single |
| No | Gutter Cross Slope (%) | 4.3 | Yes | Perpendicular Joint Present | Yes |

Remove & Replace Entire Ramp. Remove & Replace Gutter.

R304.2.2, R304.5.3, STD 1115
