# Access Compliance Report Public Rights-of-Way (Curb Ramps)

Main Street: ESENCIA\_DR Cross Street: N/A Location: SW

ADA ID: RPRK211201135205 Ramp Type: Type 1 - Perpendicular Diagonal Initial Pass/Fail: Pass Overall Compliance: Yes Severity Score: 0

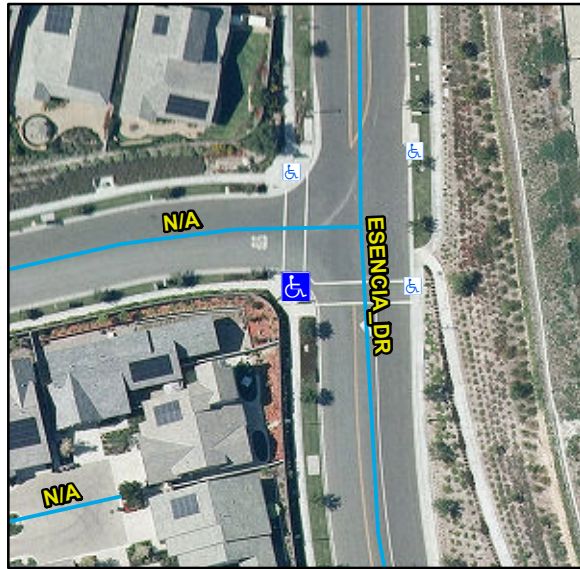
| Compliance | Description | Data | Compliance | Description | Data |
|---|---|---|---|---|---|
| Yes | Ramp Width (in) | 48 | | | Sloped |
| Yes | Ramp Run Slope (%) | 1.3 | Yes | Flare Slope LT (%) | 5.1 |
| Yes | Ramp Cross Slope (%) | 1.5 | N/A | Flare Traversable LT | Yes |
| Yes | Landing Width (in) | 48 | Yes | Flare Slope RT (%) | 4.5 |
| Yes | Landing Run Slope (%) | 1.6 | N/A | Flare Traversable RT | Yes |
| Yes | Landing Cross Slope (%) | 1.8 | Yes | DWS Provided | Yes |

N/A
