# Access Compliance Report Public Rights-of-Way (Curb Ramps)

Main Street: N/A Cross Street: MEDANO\_ST Location: E

ADA ID: RPRK211201140204 Ramp Type: Type 6 - Directional 1 Initial Pass/Fail: Pass Overall Compliance: No Severity Score: 0

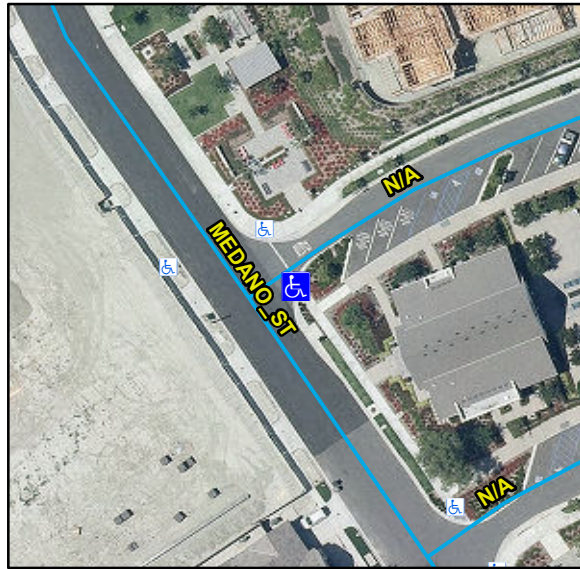
| Compliance | Description | Data | Compliance | Description | Data |
|---|---|---|---|---|---|
| No | Gutter Cross Slope (%) | 2.1 | | Parallel Ramp Side | Left |

Possible Solutions:

Remove & Replace Gutter.

OC Std/PROW:

R304.5.3, STD 1115
