# Access Compliance Report Public Rights-of-Way (Curb Ramps)

Main Street: MEDANO\_ST Cross Street: N/A Location: NE

ADA ID: RPRK211201140508 Ramp Type: Type 4 - Parallel Initial Pass/Fail: Pass Overall Compliance: No Severity Score: 0

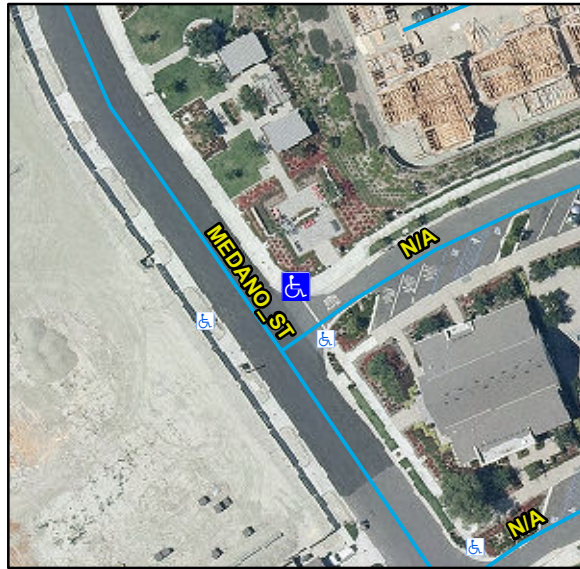
| Compliance | Description | Data | Compliance | Description | Data |
|---|---|---|---|---|---|
| Yes | Gutter Ponding | No | No | Curb Slope | 10.3 |

Remove & Replace Curb Slope.

R304.2.2, STD 1115
