# Access Compliance Report Public Rights-of-Way (Curb Ramps)

| Main Street: N/A | | Cross Street: MEDANO_ST | | Location: | SE |
| ADA ID: RPRK211201140959 | Ramp Type: Type 4 - Parallel | Initial Pass/Fail: Pass | Overall Compliance: No | Severity Score: | 0 |

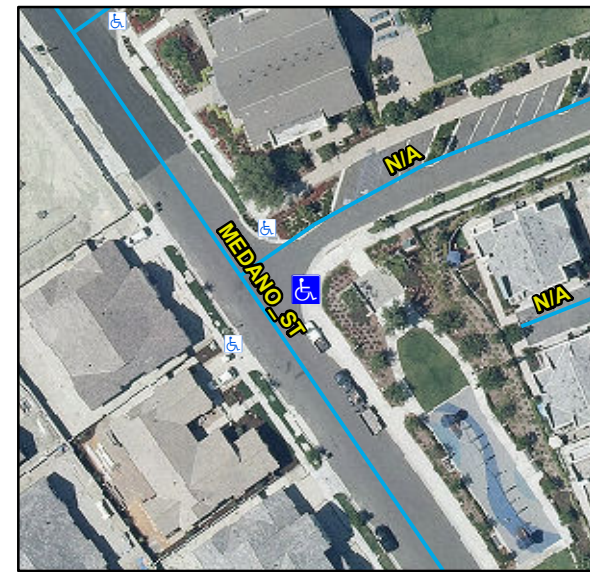
| Compliance | Description | Data | Compliance | Description | Data |
|---|---|---|---|---|---|
| Yes | Gutter Ponding | No | No | Curb Slope | 9.3 |

Possible Solutions:

**Remove & Replace Curb Slope.**

**R304.2.2, STD 1115**

Total Cost: \$ 252
