# Access Compliance Report Public Rights-of-Way (Curb Ramps)

Main Street: N/A Cross Street: MEDANO\_ST Location: NE

ADA ID: RPRK211201141326 Ramp Type: Type 7 - Directional 2 Initial Pass/Fail: Fail Overall Compliance: No Severity Score: 2

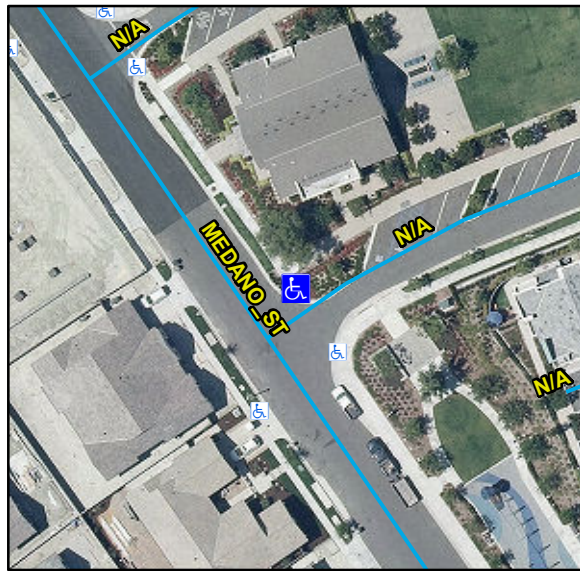
| Compliance | Description | Data | Compliance | Description | Data |
|---|---|---|---|---|---|
| No | Ramp Cross Slope (%) | 2.4 | N/A | Flare Traversable LT | N/A |

Possible Solutions:

Remove & Replace Entire Ramp.

R304.5.3, STD 1115
