# Access Compliance Report Public Rights-of-Way (Curb Ramps)

Main Street: BARACA\_DR Cross Street: PUESTO\_DR Location: SE

ADA ID: RPRK211201141939 Ramp Type: Type 1 - Perpendicular Diagonal Initial Pass/Fail: Pass Overall Compliance: No Severity Score: 2

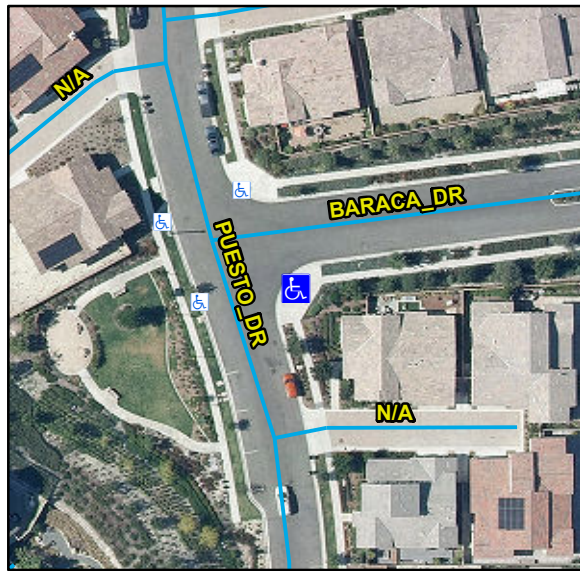
| Compliance | Description | Data | Compliance | Description | Data |
|---|---|---|---|---|---|
| No | Ramp Cross Slope (%) | 3 | N/A | Flare Traversable LT | Yes |
| No | Landing Run Slope (%) | 2.1 | N/A | Flare Traversable RT | Yes |
| No | Landing Cross Slope (%) | 2.5 | Yes | DWS Provided | Yes |
| No | Gutter Cross Slope (%) | 2.4 | | | |

Remove & Replace Curb Ramp With Two New Directional Ramps or Equivalent. Remove & Replace Gutter.

R304.5.3, R304.2.2-Perp, R304.3.2-Para, STD 1115
