# Access Compliance Report Public Rights-of-Way (Curb Ramps)

Main Street: PUESTO\_DR Cross Street: BARACA\_DR Location: NW

ADA ID: RPRK211201142355 Ramp Type: Type 1 - Perpendicular Initial Pass/Fail: Pass Overall Compliance: No Severity Score: 6

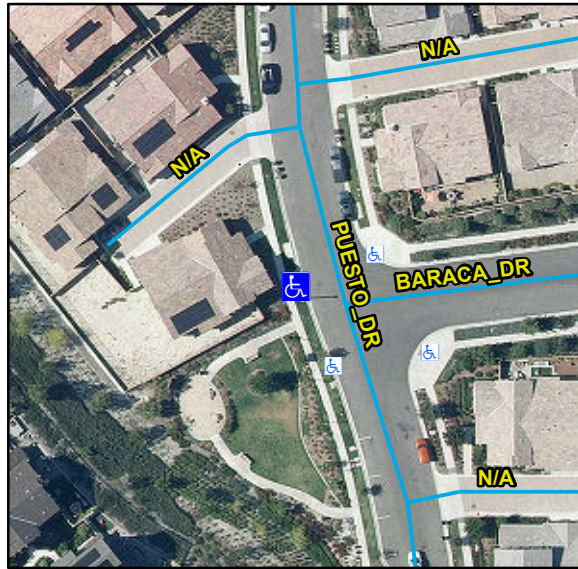
| Compliance | Description | Data | Compliance | Description | Data |
|---|---|---|---|---|---|
| No | Gutter Run Slope (%) | 12.6 | | Road Cross Slope (%) | N/A |

Possible Solutions:

Remove & Replace Gutter.

OC Std/PROW:

R304.5.4, STD 1115
