# Access Compliance Report Public Rights-of-Way (Curb Ramps)

| Main Street: BARACA_DR | | Cross Street: AIROSO_ST | | Location: | NW |
| ADA ID: RPRK211201143034 | Ramp Type: Type 3 - Combination 1 | Initial Pass/Fail: Fail | Overall Compliance: No | Severity Score: | 32 |

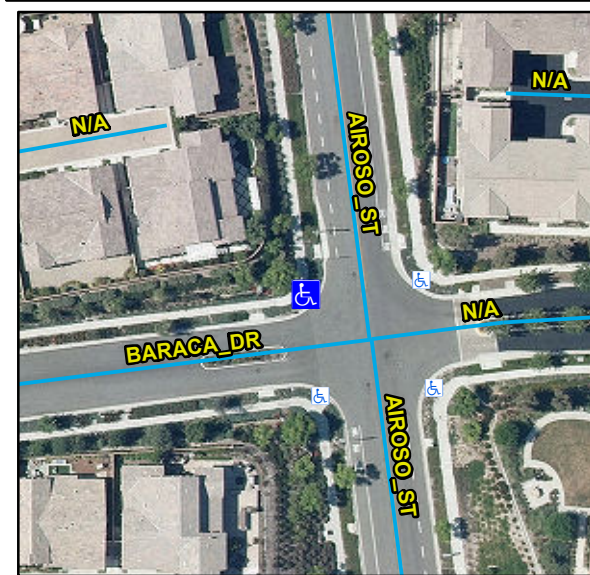
| Compliance | Description | Data | Compliance | Description | Data |
|---|---|---|---|---|---|
| Yes | Ramp Run Slope LT (%) | 4.7 | No | Ramp Run Slope RT (%) | 12.9 |
| No | Ramp Cross Slope LT (%) | 2.1 | No | Ramp Cross Slope RT (%) | 2.1 |
| No | Ramp Cross Slope (%) | 3.2 | N/A | Flare Traversable LT | N/A |

**Remove & Replace Curb Ramp With Two New Directional Ramps or Equivalent.**

**R304.5.3, R304.3.2, STD 1115**

Total Cost: \$ 6160
