# Access Compliance Report Public Rights-of-Way (Curb Ramps)

Main Street: AIROSO\_ST Cross Street: N/A Location: NE

ADA ID: RPRK211201143407 Ramp Type: Type 3 - Combination 1 Initial Pass/Fail: Fail Overall Compliance: No Severity Score: 30

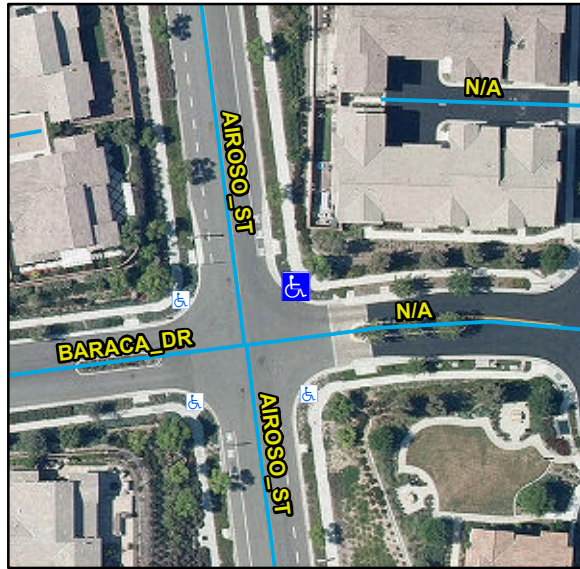
| Compliance | Description | Data | Compliance | Description | Data |
|---|---|---|---|---|---|
| No | Ramp Run Slope LT (%) | 12.5 | Yes | Ramp Run Slope RT (%) | 2.1 |
| No | Ramp Cross Slope LT (%) | 2.9 | Yes | Ramp Cross Slope RT (%) | 1.5 |

**Remove & Replace Curb Ramp With Two New Directional Ramps or Equivalent.**

**R304.2.2, R304.3.2, R304.5.3, STD 1115**

Total Cost: \$ 6160
