# Access Compliance Report Public Rights-of-Way (Curb Ramps)

Main Street: N/A Cross Street: AIROSO\_ST Location: SE

ADA ID: RPRK211201143829 Ramp Type: Type 3 - Combination 1 Initial Pass/Fail: Fail Overall Compliance: No Severity Score: 30

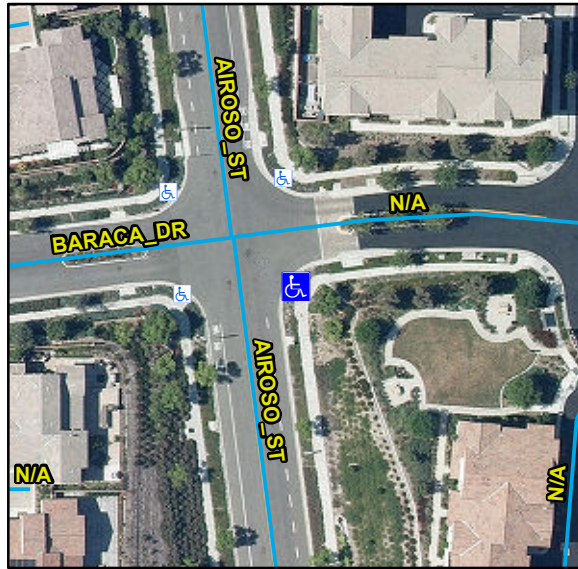
| Compliance | Description | Data | Compliance | Description | Data |
|---|---|---|---|---|---|
| Yes | Ramp Run Slope LT (%) | 7.1 | No | Ramp Run Slope RT (%) | 12.6 |
| Yes | Ramp Cross Slope LT (%) | 2 | No | Ramp Cross Slope RT (%) | 3.2 |

Remove & Replace Curb Ramp With Two New Directional Ramps or Equivalent.

R304.2.2, R304.3.2, R304.5.3, STD 1115
