# Access Compliance Report Public Rights-of-Way (Curb Ramps)

Main Street: AIROSO\_ST Cross Street: BARACA\_DR Location: SW

ADA ID: RPRK211201144137 Ramp Type: Type 3 - Combination 1 Initial Pass/Fail: Fail Overall Compliance: No Severity Score: 30

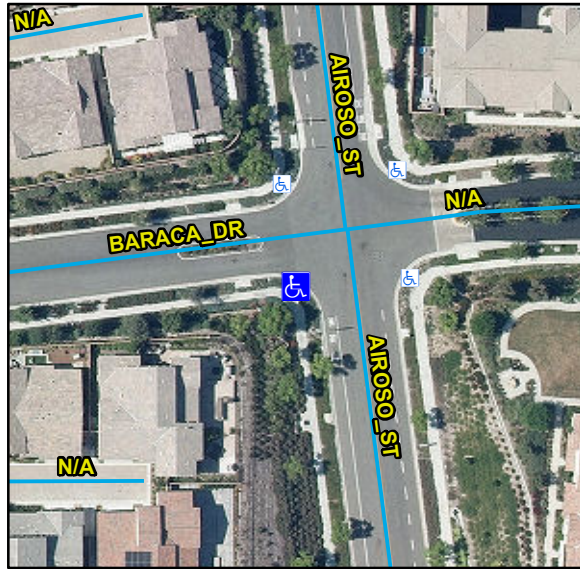
| Compliance | Description | Data | Compliance | Description | Data |
|---|---|---|---|---|---|
| No | Ramp Run Slope LT (%) | 15.7 | No | Ramp Run Slope RT (%) | 11.5 |

**Remove & Replace Curb Ramp With Two New Directional Ramps or Equivalent.**

**R304.3.2, STD 1115**

Total Cost: \$ 6160
