# Access Compliance Report Public Rights-of-Way (Curb Ramps)

Main Street: SKLAR\_ST Cross Street: N/A Location: NE

ADA ID: RPRK211202112625 Ramp Type: Type 4 - Parallel Initial Pass/Fail: Fail Overall Compliance: No Severity Score: 16

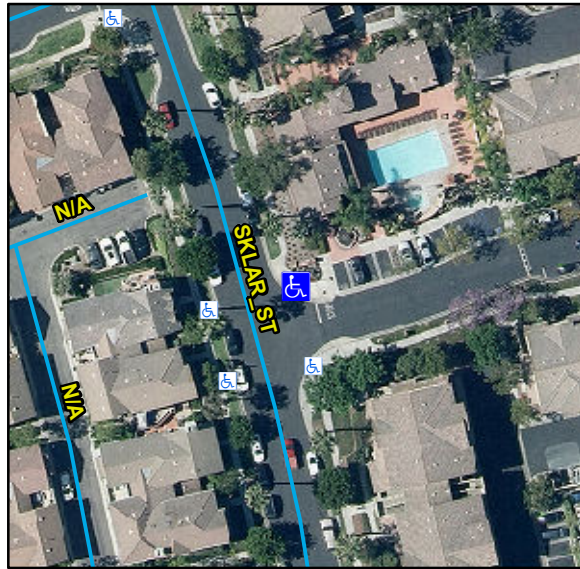
| Compliance | Description | Data | Compliance | Description | Data |
|---|---|---|---|---|---|
| Yes | Ramp Run Slope LT (%) | 2.4 | No | Ramp Run Slope RT (%) | 9.7 |
| No | Ramp Cross Slope LT (%) | 2.5 | No | Ramp Cross Slope RT (%) | 3.1 |

**Remove & Replace Curb Ramp With Two New Directional Ramps or Equivalent.**

**R204.3, R304.5.3, R304.3.2, STD 1115**

Total Cost: \$ 4000
