# Access Compliance Report Public Rights-of-Way (Curb Ramps)

Main Street: N/A Cross Street: SKLAR\_ST Location: SE

ADA ID: RPRK211202113004 Ramp Type: Type 4 - Parallel Initial Pass/Fail: Pass Overall Compliance: No Severity Score: 20

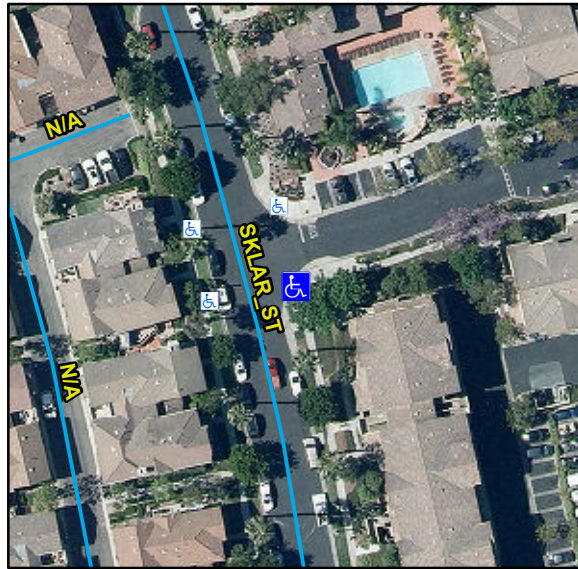
| Compliance | Description | Data | Compliance | Description | Data |
|---|---|---|---|---|---|
| N/A | Landing Present | No | No | DWS Provided | No |
| No | Landing Width (in) | N/A | N/A | DWS Length (in) | N/A |
| No | Landing Run Slope (%) | N/A | N/A | DWS Full Width | N/A |
| No | Landing Cross Slope (%) | N/A | | DWS Offset Type | N/A |
| No | Gutter Cross Slope (%) | 2.1 | No | Perpendicular Joint Present | No |

Remove & Replace Curb Ramp With Two New Directional Ramps or Equivalent. Remove & Replace Gutter.
