# Access Compliance Report Public Rights-of-Way (Curb Ramps)

Main Street: SKLAR\_ST Cross Street: N/A Location: N

ADA ID: RPRK211202113602 Ramp Type: Type 4 - Parallel Initial Pass/Fail: Pass Overall Compliance: No Severity Score: 25

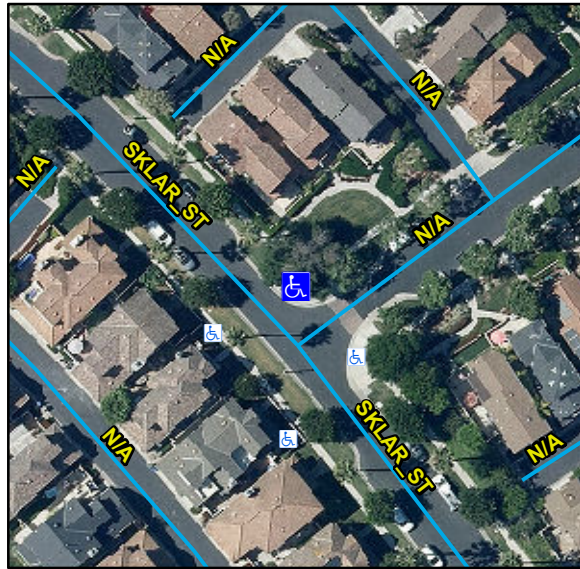
| Compliance | Description | Data | Compliance | Description | Data |
|---|---|---|---|---|---|
| Yes | Ramp Run Slope LT (%) | 2.8 | Yes | Ramp Run Slope RT (%) | 3.8 |
| N/A | Landing Present | No | No | DWS Provided | No |
| Yes | Gutter Ponding | No | No | Curb Slope | 10.3 |
| No | Gutter Run Slope (%) | 6.3 | | Road Cross Slope (%) | 4.5 |
| Yes | Gutter Cross Slope (%) | 0.5 | No | Perpendicular Joint Present | No |

Remove & Replace Curb Ramp With Two New Directional Ramps or Equivalent. Remove & Replace Gutter.
