# Access Compliance Report Public Rights-of-Way (Curb Ramps)

Main Street: N/A Cross Street: SKLAR\_ST Location: E

ADA ID: RPRK211202114000 Ramp Type: Type 4 - Parallel Initial Pass/Fail: Fail Overall Compliance: No Severity Score: 2

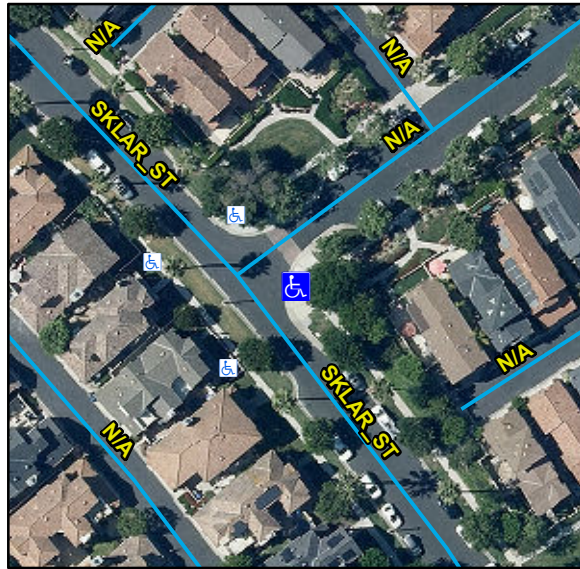
| Compliance | Description | Data | Compliance | Description | Data |
|---|---|---|---|---|---|
| No | Ramp Cross Slope LT (%) | 4.2 | No | Ramp Cross Slope RT (%) | 2.9 |

**Remove & Replace Curb Ramp With Two New Directional Ramps or Equivalent.**

**R204.3, R304.5.3, STD 1115**
