# Access Compliance Report Public Rights-of-Way (Curb Ramps)

| Main Street: N_DAISSY_ST | | Cross Street: N/A | | Location: | SW |
| ADA ID: RPRK211202114532 | Ramp Type: Type 4 - Parallel | Initial Pass/Fail: Fail | Overall Compliance: No | Severity Score: | 16 |

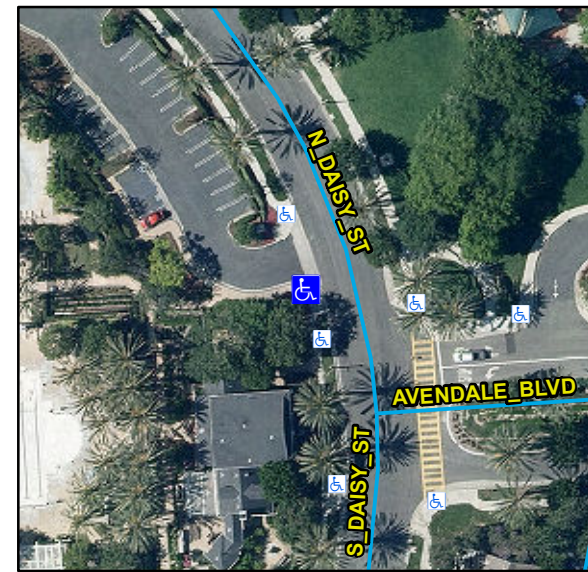
| Compliance | Description | Data | Compliance | Description | Data |
|---|---|---|---|---|---|
| Yes | Ramp Run Slope LT (%) | 2.4 | No | Ramp Run Slope RT (%) | 9.5 |
| No | Ramp Cross Slope LT (%) | 4.4 | Yes | Ramp Cross Slope RT (%) | 1.9 |

**Remove & Replace Curb Ramp With Two New Directional Ramps or Equivalent.**

**R204.3, R304.5.3, R304.3.2, STD 1115**

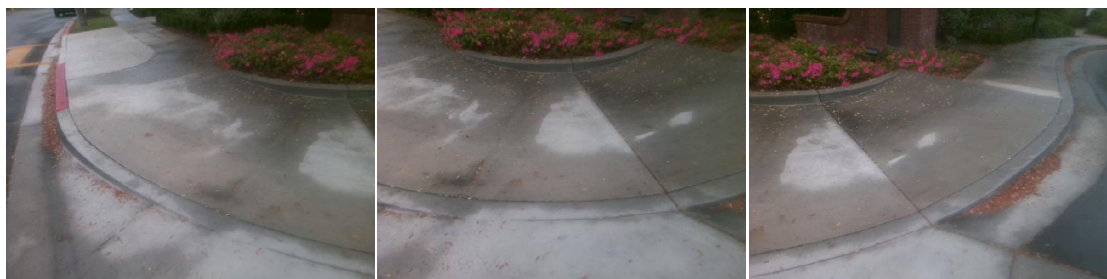
| Compliance | Description | Data | Compliance | Description | Data |
|---|---|---|---|---|---|
| N/A | Ramp Length LT (in) | 104 | N/A | Ramp Length RT (in) | 104 |
| Yes | Ramp Width LT (in) | 89 | Yes | Ramp Width RT (in) | 89 |
