# Access Compliance Report Public Rights-of-Way (Curb Ramps)

Main Street: N/A Cross Street: N\_DAISSY\_ST Location: NW

ADA ID: RPRK211202114958 Ramp Type: Type 4 - Parallel Initial Pass/Fail: Fail Overall Compliance: No Severity Score: 16

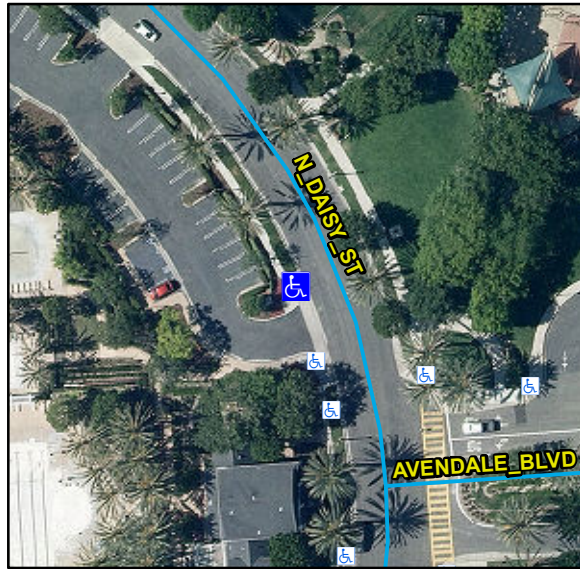
| Compliance | Description | Data | Compliance | Description | Data |
|---|---|---|---|---|---|
| <b>No</b> | Ramp Run Slope LT (%) | <b>9.4</b> | <b>Yes</b> | Ramp Run Slope RT (%) | <b>4.4</b> |
| <b>Yes</b> | Ramp Cross Slope LT (%) | <b>1.3</b> | <b>No</b> | Ramp Cross Slope RT (%) | <b>3.1</b> |

**Remove & Replace Curb Ramp With Two New Directional Ramps or Equivalent.**

**R204.3, R304.3.2, R304.5.3, STD 1115**
