# Access Compliance Report Public Rights-of-Way (Curb Ramps)

Main Street: FALABELLA\_DR Cross Street: FALABELLA\_DR Location: S

ADA ID: RPRK211202115722 Ramp Type: Type 1 - Perpendicular Initial Pass/Fail: Pass Overall Compliance: No Severity Score: 5

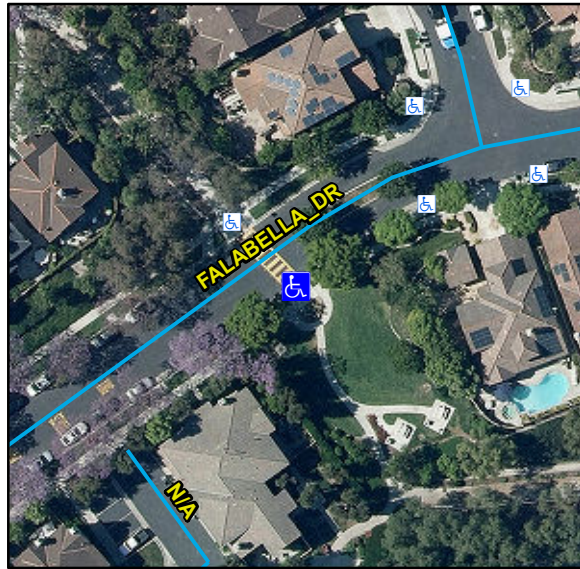
| Compliance | Description | Data | Compliance | Description | Data |
|---|---|---|---|---|---|
| No | Gutter Run Slope (%) | 8.8 | | Road Cross Slope (%) | N/A |

Possible Solutions:

Remove & Replace Gutter.

R304.5.4, STD 1115
